LETTER REPORT  
FOR  
MICHCON "H"  
DETROIT, WAYNE COUNTY, MICHIGAN  
TDD S05-9801-020  
PAN 8J2001SDXX

March 30, 1998

Re: MichCon "H"  
Detroit, Wayne County, Michigan  
TDD S05-9801-020  
PAN 8J2001SIXX

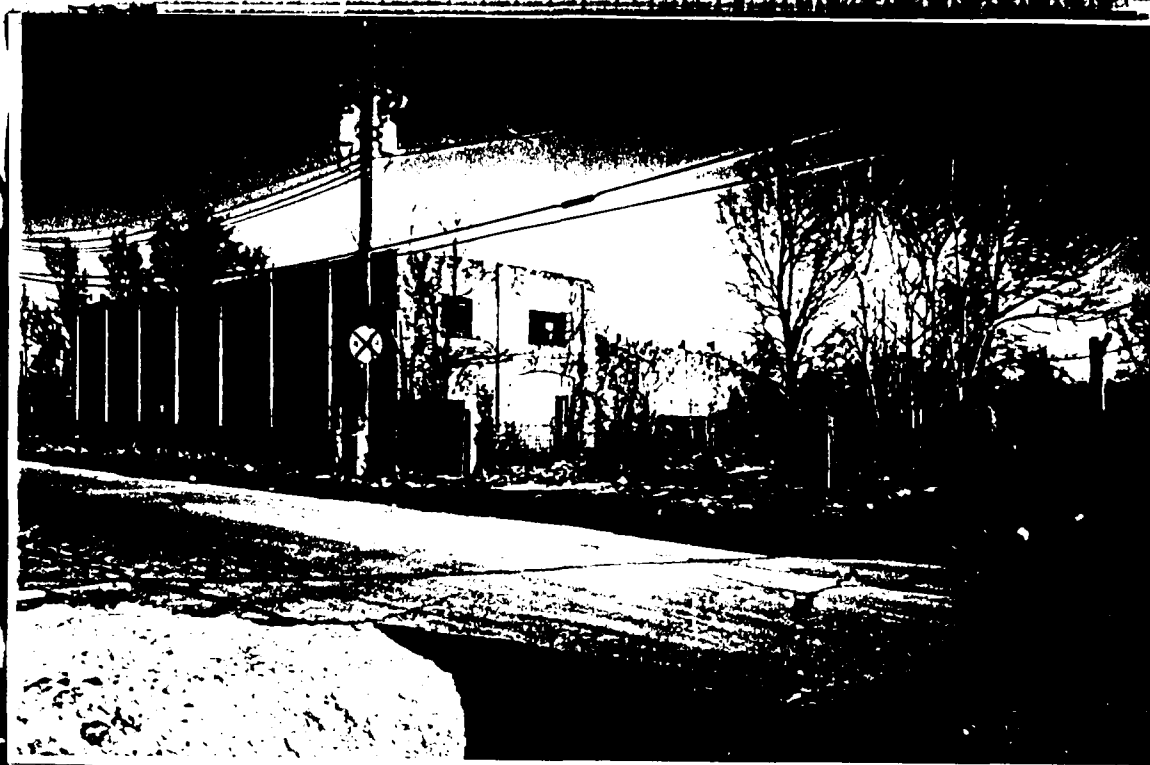
Site: MichCon "H"  
 Photo No: 1 (R1F1)  
 Direction: North  
 Camera: Minolta 35mm  
 Photographer: Mark Ramaly

Date: 2/3/98  
 Subject: View of southwestern side of site and Building 1  
 from South Green Avenue.

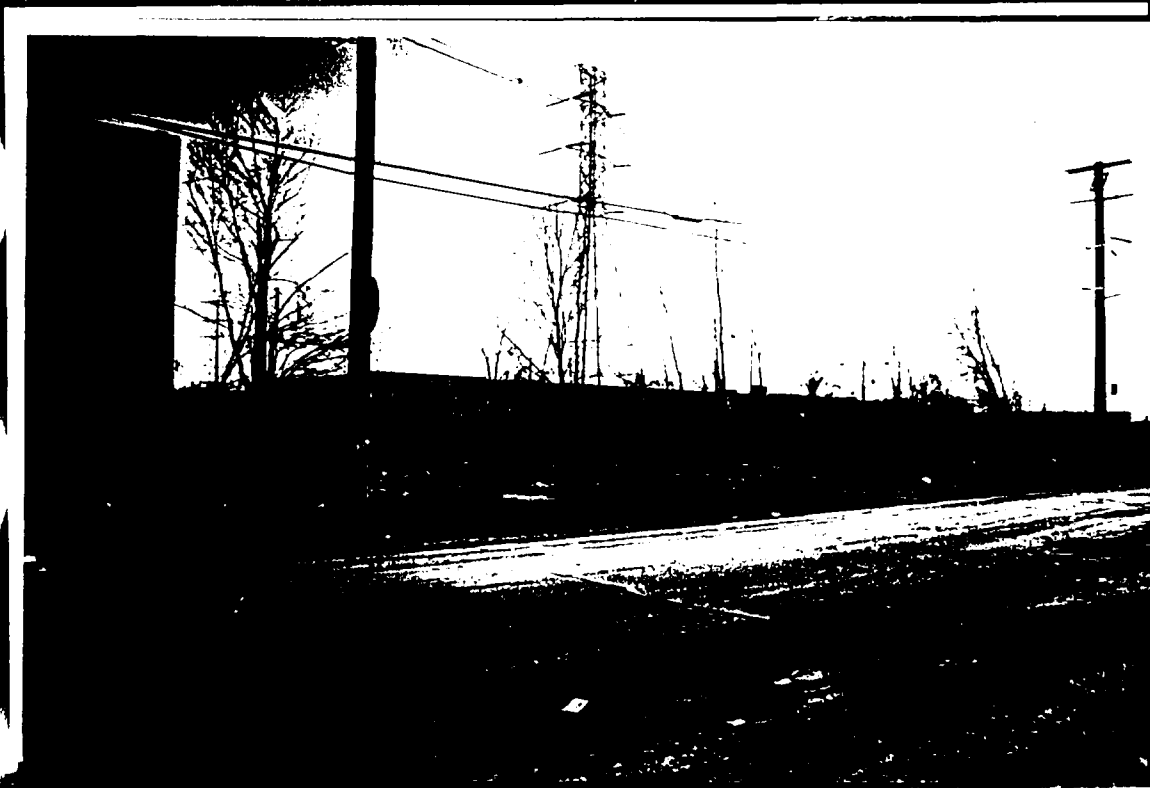
Site: MichCon "H"  
 Photo No: 2 (R1F2)  
 Direction: Southeast  
 Camera: Minolta 35mm  
 Photographer: Mark Ramaly

Date: 2/3/98  
 Subject: View of southwestern side of site from South  
 Green Avenue.

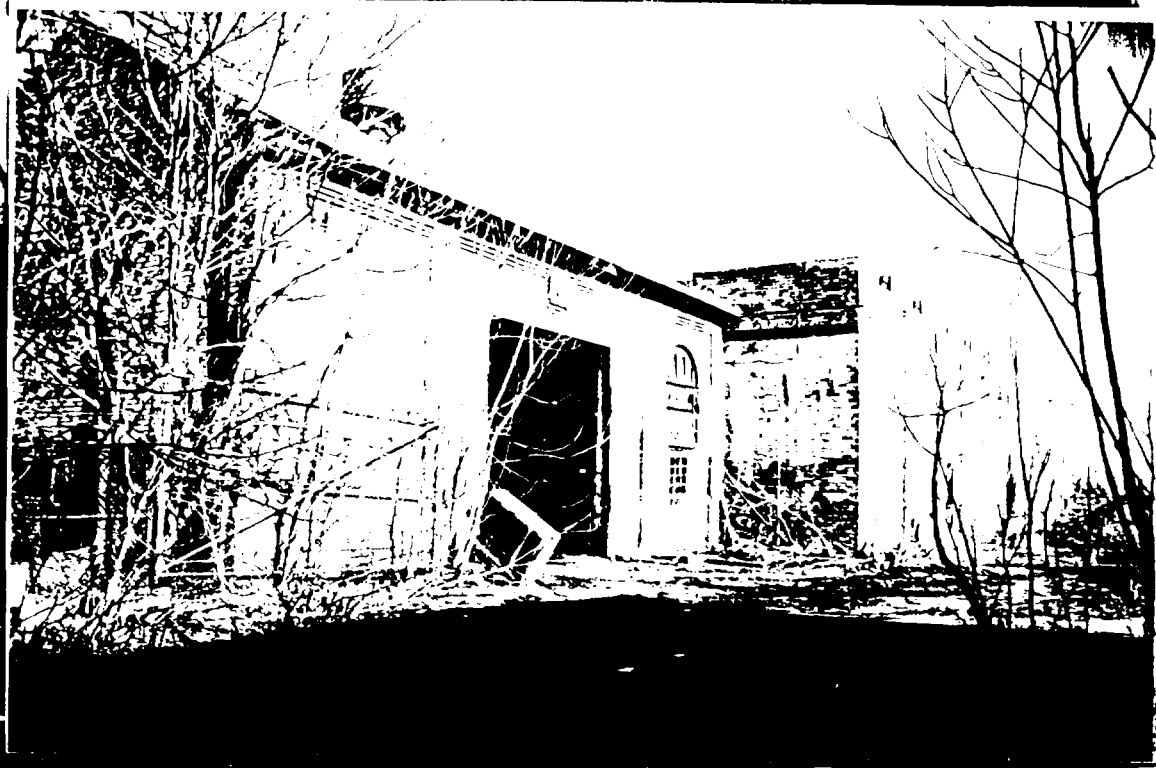
Site: MichCon "H"  
Photo No: 5 (R2F4)  
Direction: Northwest  
Camera: Minolta 35mm  
Photographer: Mark Ramaly

Date: 2/3/98  
Subject: Western portion of Building 2.

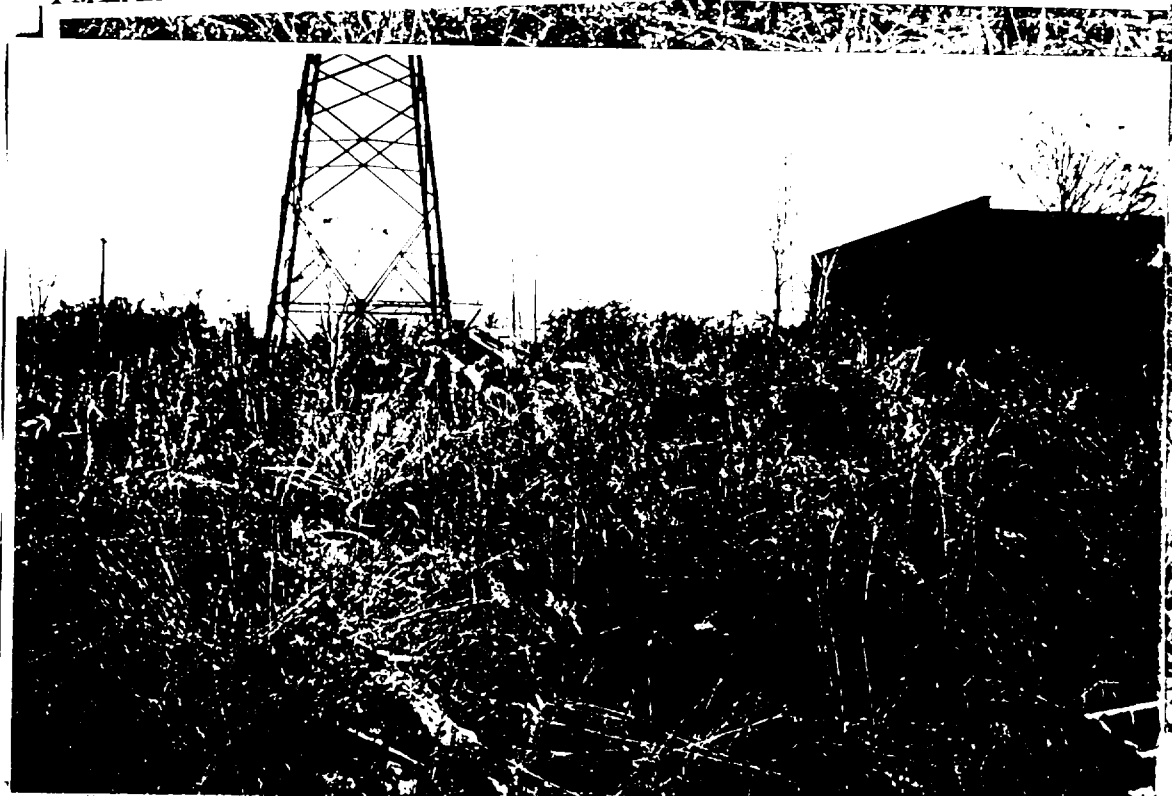
Site: MichCon "H"  
 Photo No: 22 (R1F9)  
 Direction: East  
 Camera: Minolta 35mm  
 Photographer: Mark Ramaly

Date: 2/3/98  
 Subject: Two drums containing material located at the  
 Date: 2/3/98  
 Subject: Southwestern portion of Pile 3. Note tires and debris scattered throughout the pile.

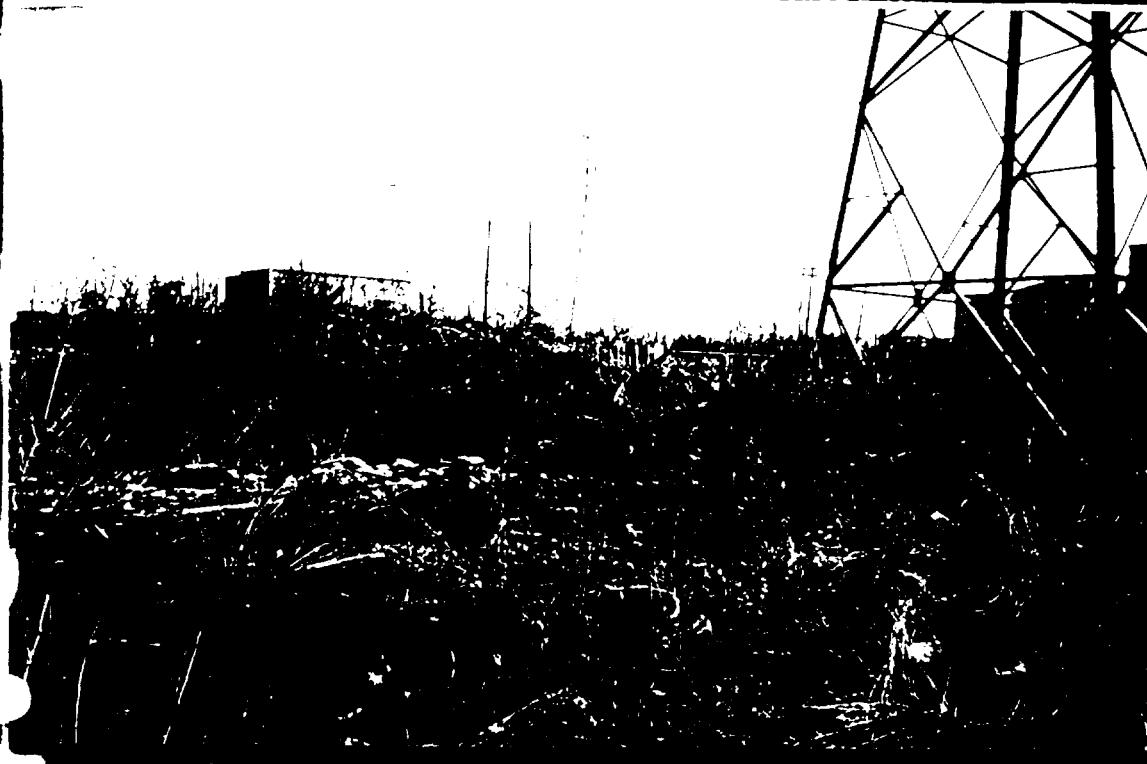
**Site:** MichCon "H"  
**Photo No:** 23 (R1F10)  
**Direction:** East  
**Camera:** Minolta 35mm  
**Photographer:** Mark Ramaly

Pile 3, which was Y-shaped, was located on the southeastern corner of the site, and a high-voltage electrical tower was located in the center. The pile consisted of black topsoil, sand, gravel, concrete, wood, roofing material, bricks, carpeting, tires, rubber, and other debris. The northwestern portion of the pile consisted primarily of automobile fuel tanks and rusted 1-gallon and 5-gallon containers. Dried yellow solids were visible inside the small containers and on the pile. In addition to various debris, several rusted 5-gallon containers, empty drum carcasses, and six partially buried drums were located on the northeastern side of the pile. Pile 3 was approximately 160 feet from east to west by 60 feet from north to south in area, and 10 feet in height.

**Date:** 2/3/98  
**Subject:** Northern portion of Pile 3. Note high voltage tower near Pile 3.
